Movement of Tagged Dredged Sand at Thalweg Disposal Sites in the Upper Mississippi River

Volume 3:
Additional Results at Gordon's Ferry
and Whitney Island Sites

ANL/EES-TM-270, Vol. 3

April 1985

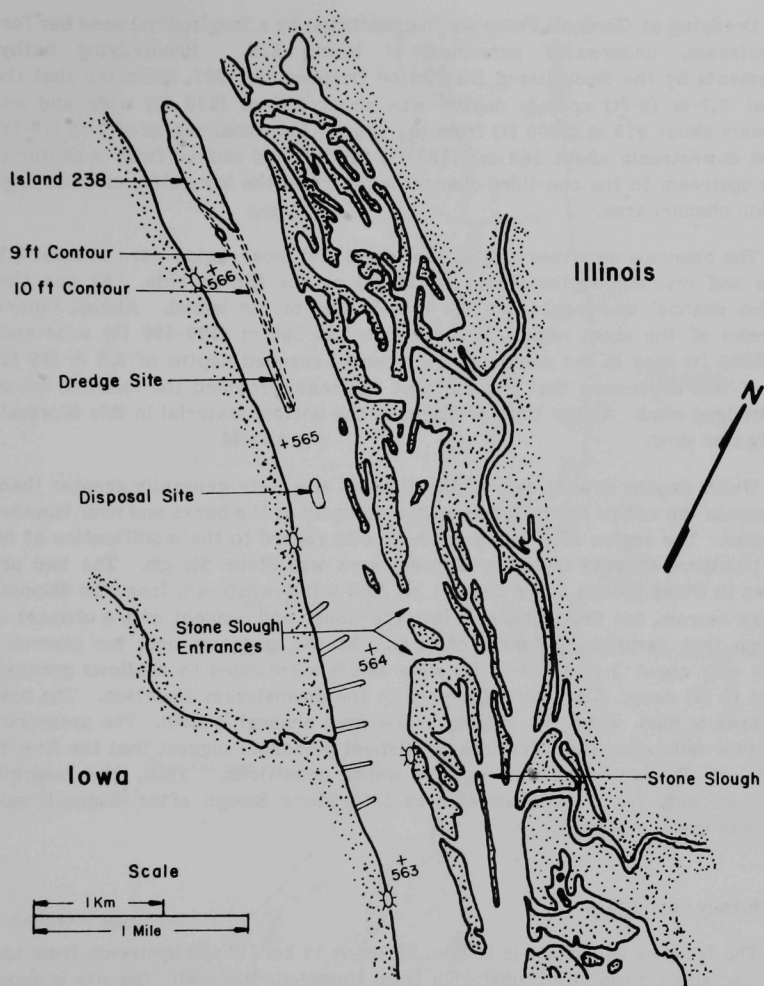
FIGURE 2 Gordon's Ferry Experimental Site in Pool 12 of the Upper Mississippi River

The reach in which the experiment was conducted is relatively straight, varying in width from 400 m (1300 ft) to 600 m (2000 ft). The Iowa bank is steep and rises abruptly in a railroad embankment revetted with rock. Downstream from the disposal area are six submerged wing dams along the Iowa shore. The Illinois side of the river is marked by lowlands cut through with sloughs and backwaters for at least 0.8 km (0.5 mi) inland. The normal river channel is well defined by the river sides of islands. Three small islands are located in the channel near the Illinois bank; downstream from the disposal area are two openings into Stone Slough. The navigation channel is on the Iowa side of the river in this reach. The bottom sediments are clean sands that generally range in size from fine to coarse. Gravel has occasionally been found in bottom samples, and mud occurs in the backwaters and sloughs. The bottom conditions found in the main channel of this reach include both flat-bed and dune regimes.

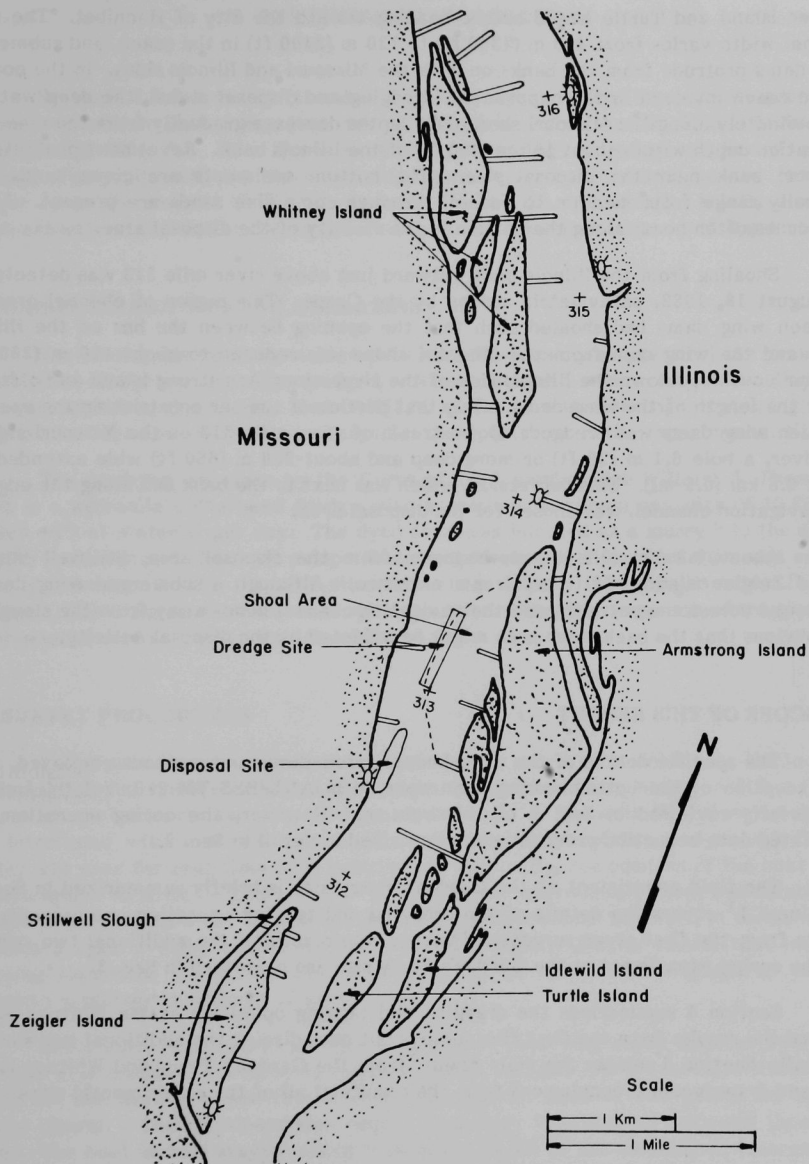
FIGURE 3 Whitney Island Experimental Site in Pool 22 of the Upper Mississippi River

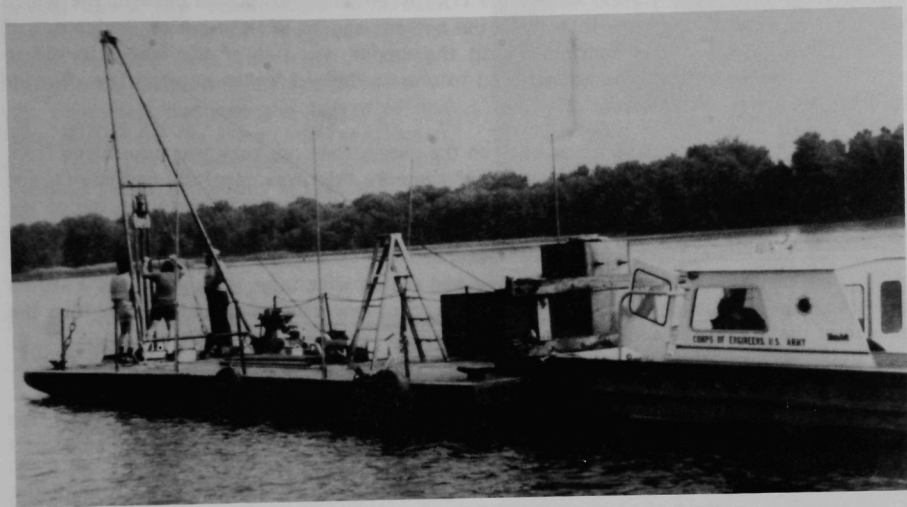
FIGURE 6 12.2-m Pontoon Barge Used for the Coring Operation

The vibracorer was positioned on the river bottom in the following manner. The Argonne survey boat was driven to the location to be cored using the high-resolution position-plotting system. When the boat was at the coring location, the depth was recorded and a buoy was attached to an anchor with a line whose length was only about a foot longer than the depth. With the boat pilot maintaining the position as close as possible to the desired coring location, the buoy was dropped overboard from a position in the stern of the boat immediately below the receiver/transmitter for the positioning system. The survey boat then moved away and returned to the buoy to check its position. If the position of the buoy was not within a few feet of the desired location, the buoy was dragged into position.

With the barge in position, the coring device was lifted off the deck, and the vibrator was activated while the device was out of the water. The coring device was then lowered to the river bottom, and the support cable was allowed to go slack. The time was noted, and the cable was marked with tape to provide a reference point for monitoring the progress of the core tube as it penetrated the bottom sediments.

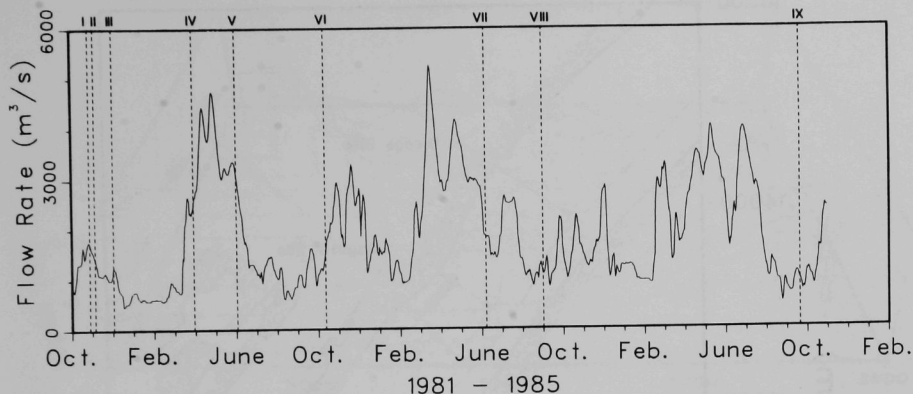
FIGURE 10 Mean Daily River Discharge for the Gordon's Ferry Site as Recorded at Lock and Dam 12, with the Dates of the Surveys Indicated

The disposal pile remained a distinct bathymetric feature until the first period of high flow after disposal (see Fig. 10) in the spring of 1982. Bathymetric measurements made after this spring flood showed that sand dunes were present in the disposal area, probably indicating a return to the bottom forms existing prior to disposal. However, it was not until after a second spring flood a year later (Survey VII) that significant downstream movement of the tagged sand was observed. Figure 14 shows the distribution of tagged sand at the Gordon's Ferry site immediately after disposal (Survey I) and

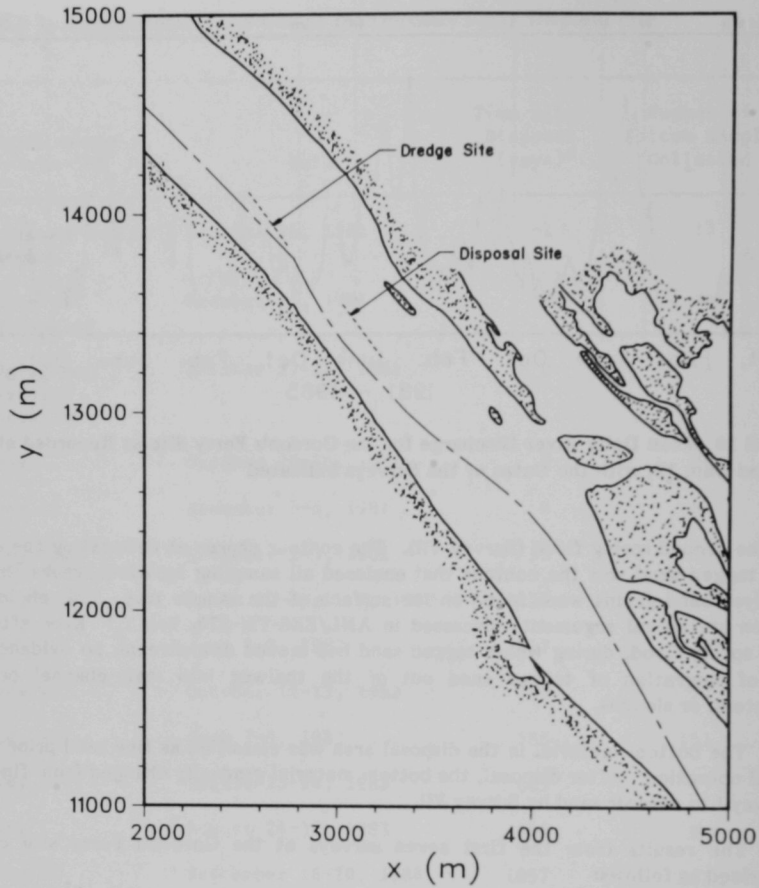
FIGURE 11 Map of Gordon's Ferry Site Showing Dredging and Disposal Areas

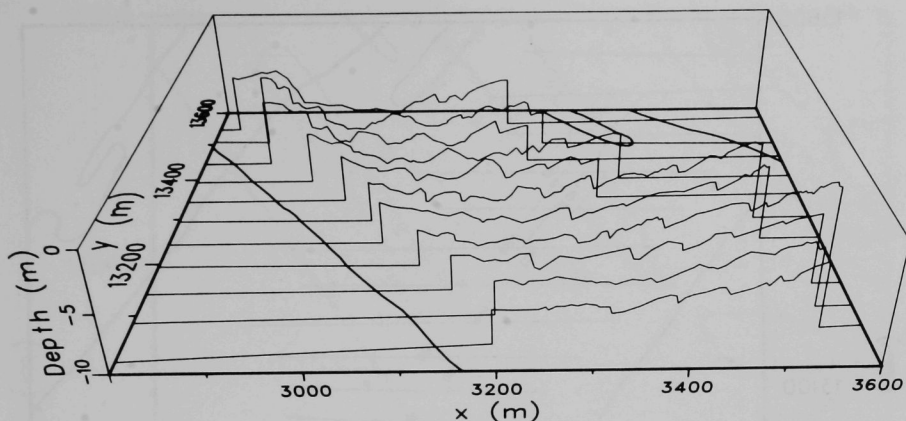
FIGURE 12 Perspective Plot of Bathymetric Transects for Survey I at the Gordon's Ferry Disposal Site

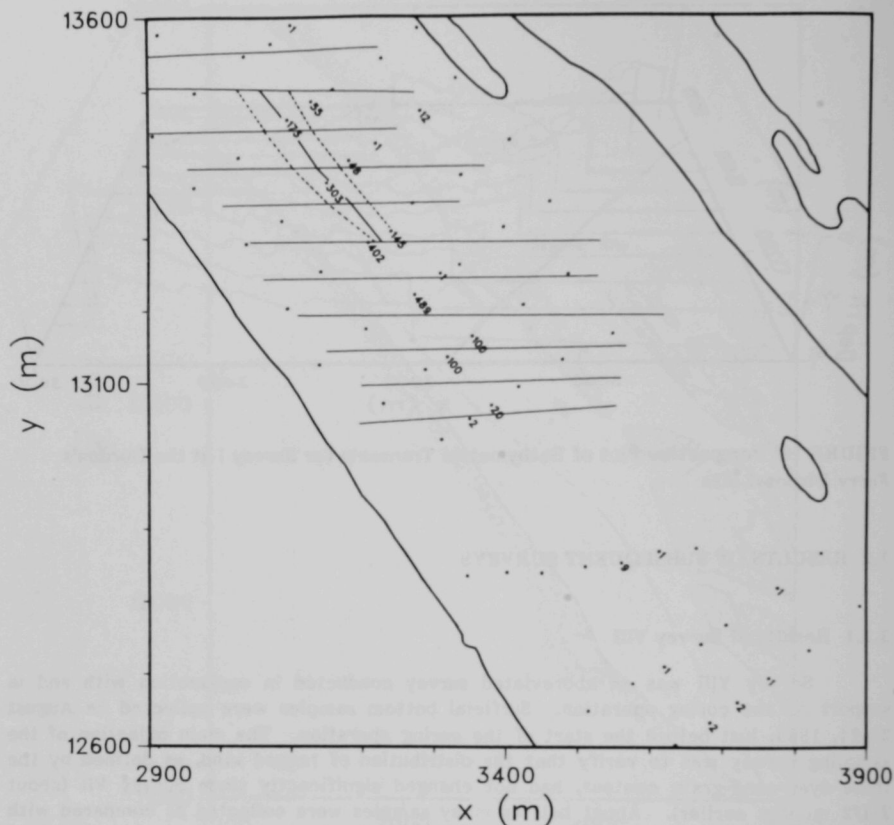
FIGURE 13 Location of Bathymetric Transects and Bottom Sampling Stations for Survey I at the Gordon's Ferry Disposal Site (location of the pile and the number of dyed sand grains observed are noted)

Figure 13 shows the bottom sampling locations for the first survey, the number of dyed sand grains observed on the surface of the sample tray at each location, the paths of the bathymetric transects, and the location of the peak and the lateral extent of the disposal pile as determined from the bathymetric survey. An area yielding samples with significant counts of dyed sand (>3) extended about 500 m downstream of where the physical pile appeared on the bathymetric transects.

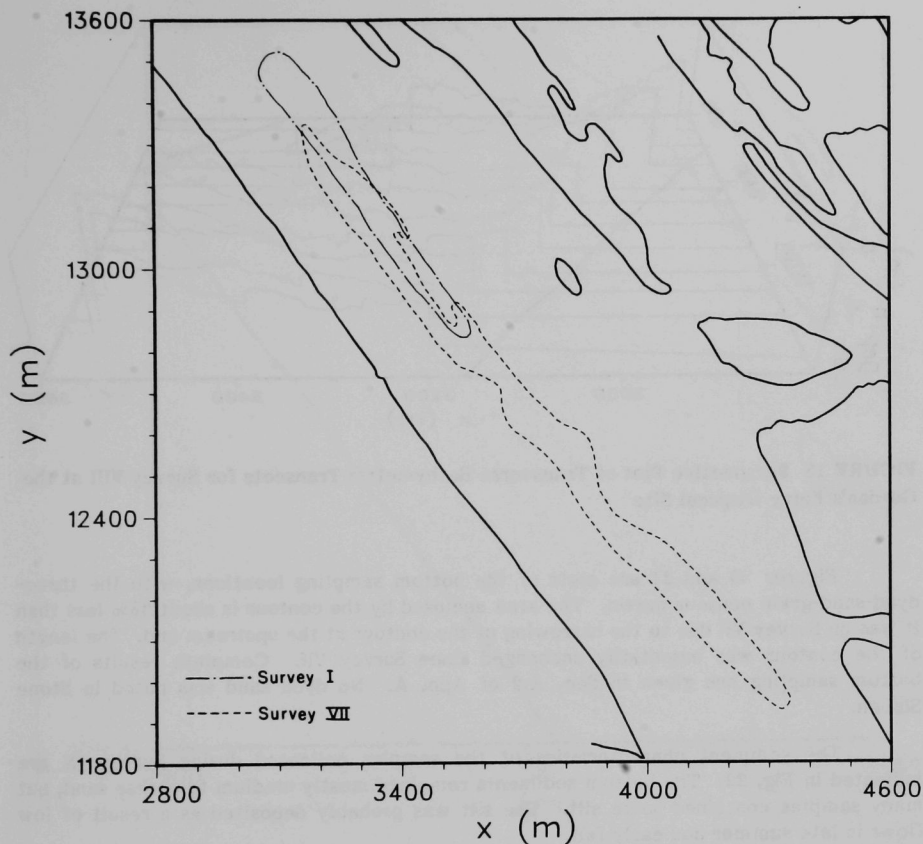
FIGURE 14 Distribution of Tagged Sand after Disposal (Survey I) and after the Second Spring Flood (Survey VII) at the Gordon's Ferry Disposal Site

after the second spring flood (Survey VII). The contour chosen as delineating the extent of the tagged sand was the contour that enclosed all sampling locations where three or more dyed sand grains were found on the surface of the sample tray. This choice was based on statistical arguments discussed in ANL/EES-TM-270, Vol. 1.¹ Even after the second spring flood, during which tagged sand had moved downstream, no evidence was found of migration of tagged sand out of the thalweg into main-channel borders, backwaters, or sloughs.

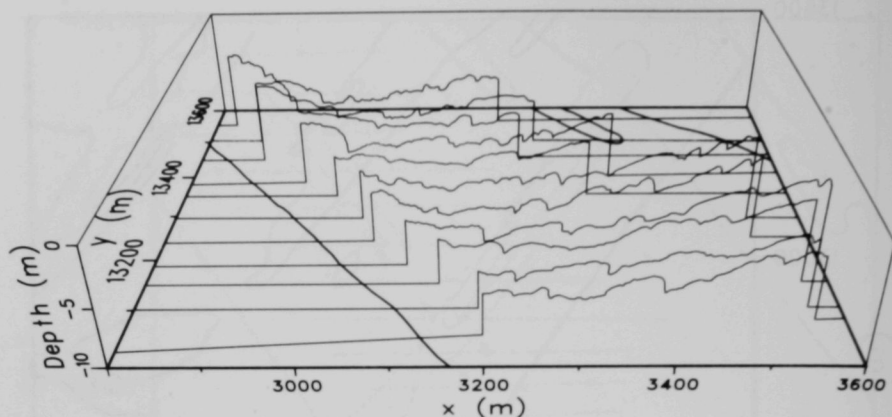
FIGURE 15 Perspective Plot of Transverse Bathymetric Transects for Survey VIII at the Gordon's Ferry Disposal Site

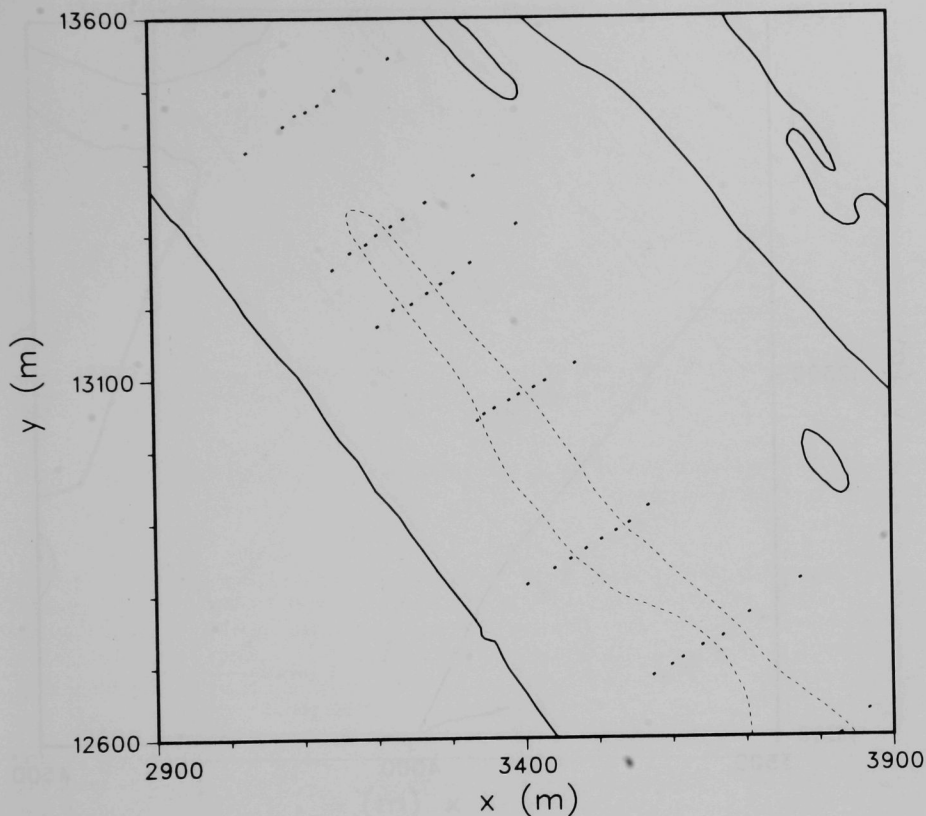
FIGURE 16 Sampling Locations and the Three-Dyed-Sand-Grain Contour for Survey VIII at the Gordon's Ferry Disposal Site

The bottom sampling locations and the three-dyed-sand-grain contour for Survey VIII are shown in Figs. 16 and 17. The contour is not complete near the downstream end because of the abbreviated nature of this survey. Little change had occurred since the previous survey, except that the contour does not appear to be quite as wide, especially near the upstream end. This narrowing may be related to a brief period of higher-than-average flow that occurred in July 1983 (see Fig. 10). The complete results from the

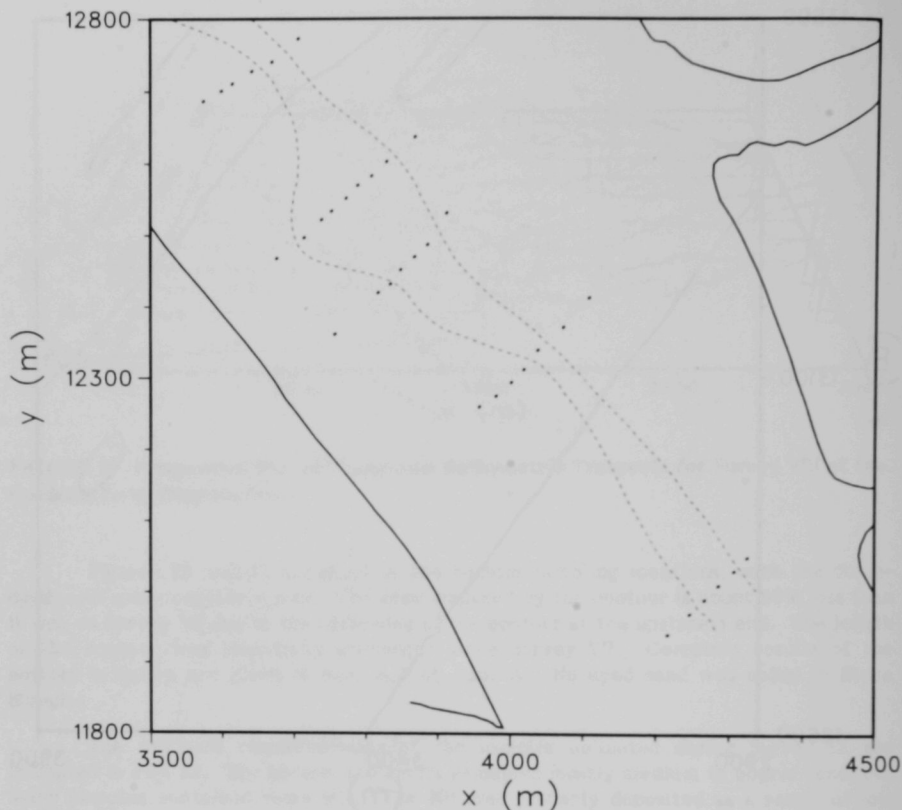
FIGURE 17 Sampling Locations and the Three-Dyed-Sand-Grain Contour for Survey VIII Downstream of the Gordon's Ferry Disposal Site

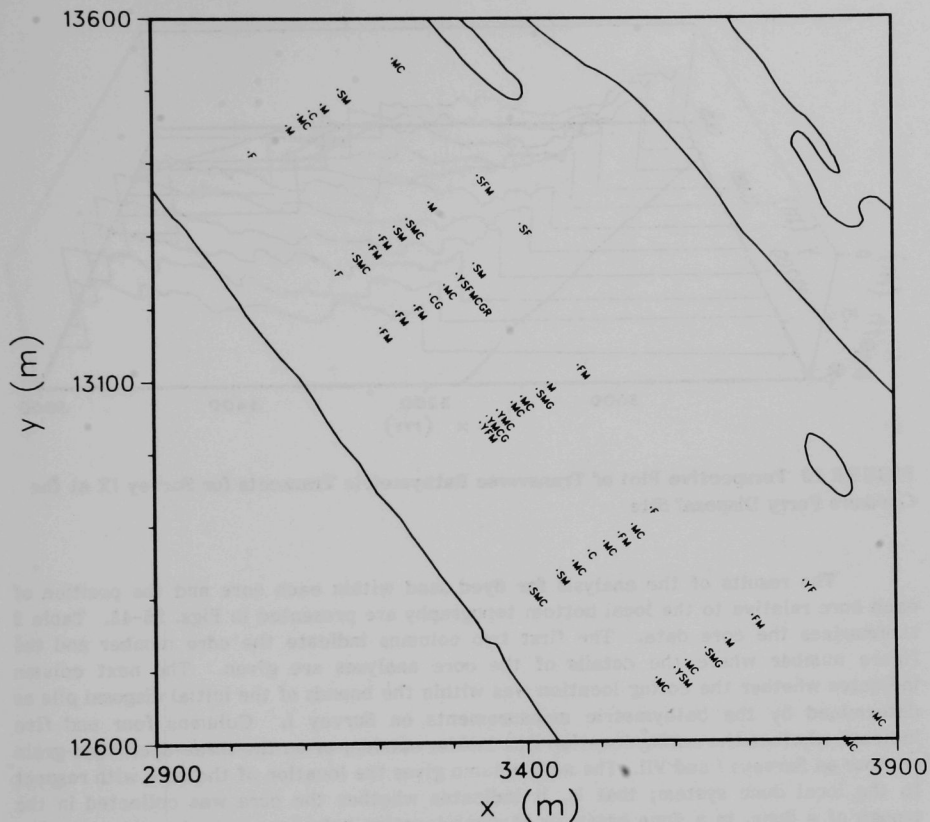
FIGURE 18 Approximate Classification of Bottom Sediments at Sampling Locations for Survey VIII at the Gordon's Ferry Disposal Site

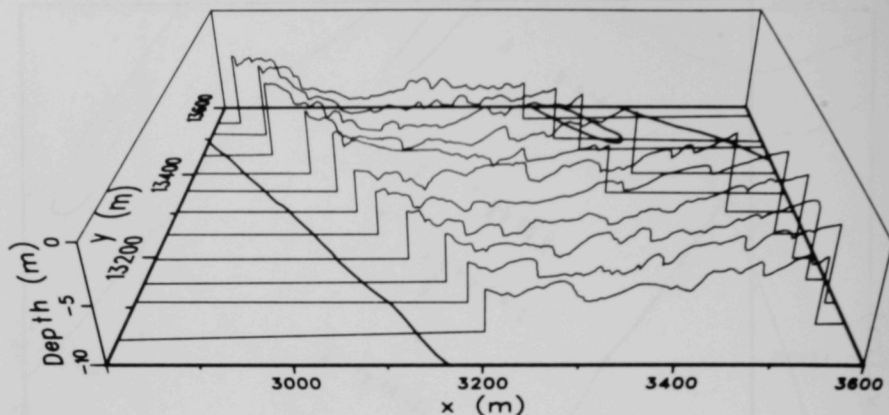
FIGURE 19 Perspective Plot of Transverse Bathymetric Transects for Survey IX at the Gordon's Ferry Disposal Site

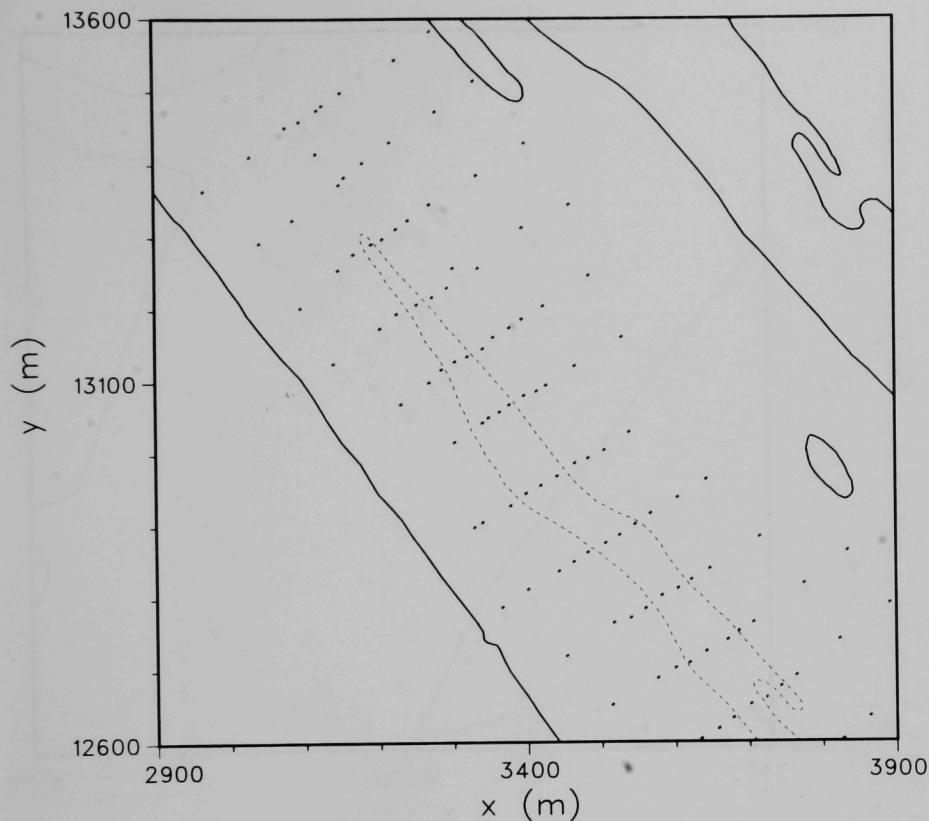
FIGURE 20 Sampling Locations and the Three-Dyed-Sand-Grain Contour for Survey IX at the Gordon's Ferry Disposal Site

Figures 20 and 21 are plots of the bottom sampling locations, with the three-dyed-sand-grain contour drawn. The area enclosed by the contour is about 30% less than it was on Survey VII due to the narrowing of the contour at the upstream end. The length of the contour was essentially unchanged since Survey VII. Complete results of the bottom sampling are given in Sec. A.2 of App. A. No dyed sand was noted in Stone Slough.

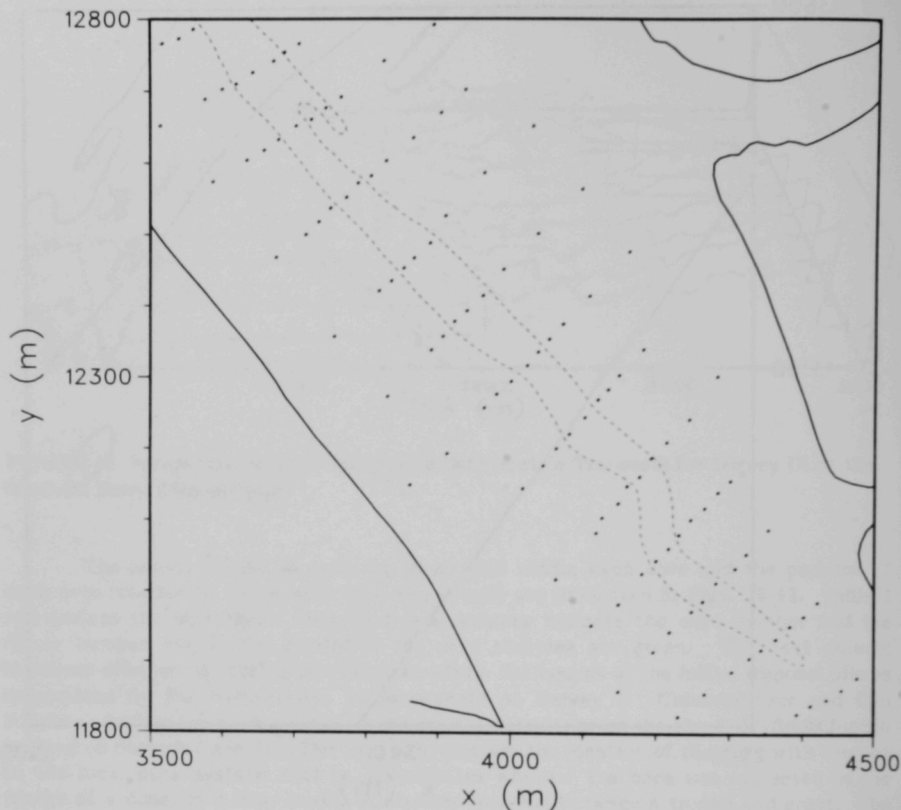
FIGURE 21 Sampling Locations and the Three-Dyed-Sand-Grain Contour for Survey IX Downstream of the Gordon's Ferry Disposal Site

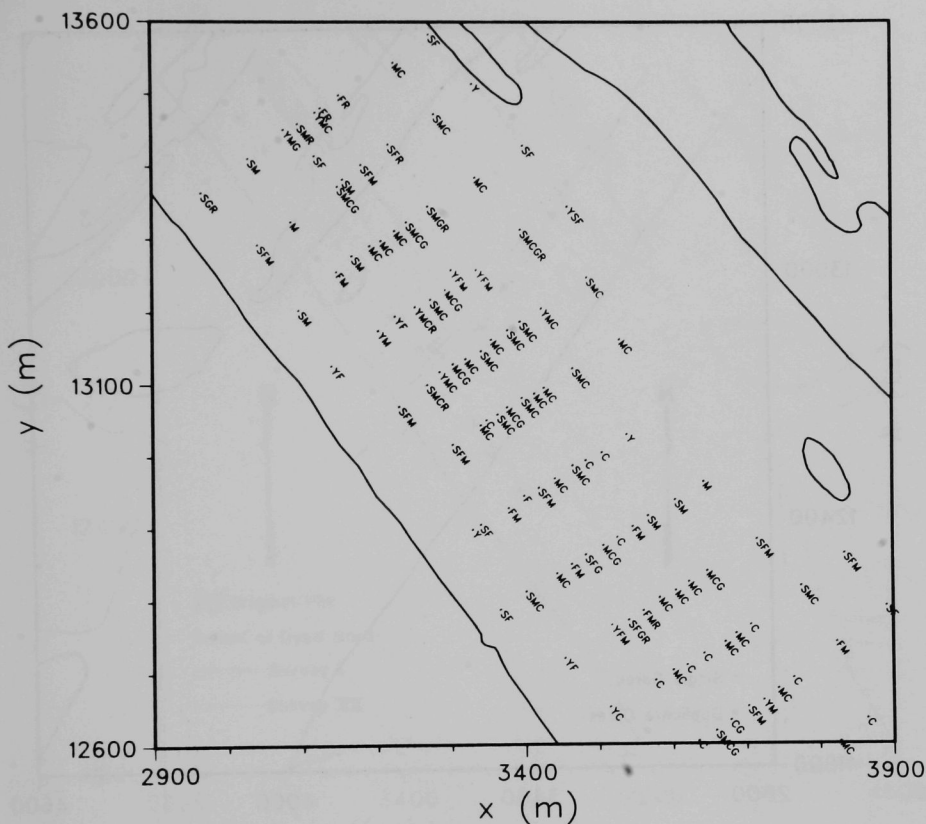
FIGURE 22 Approximate Classification of Bottom Sediments at Sampling Locations for Survey IX at the Gordon's Ferry Disposal Site

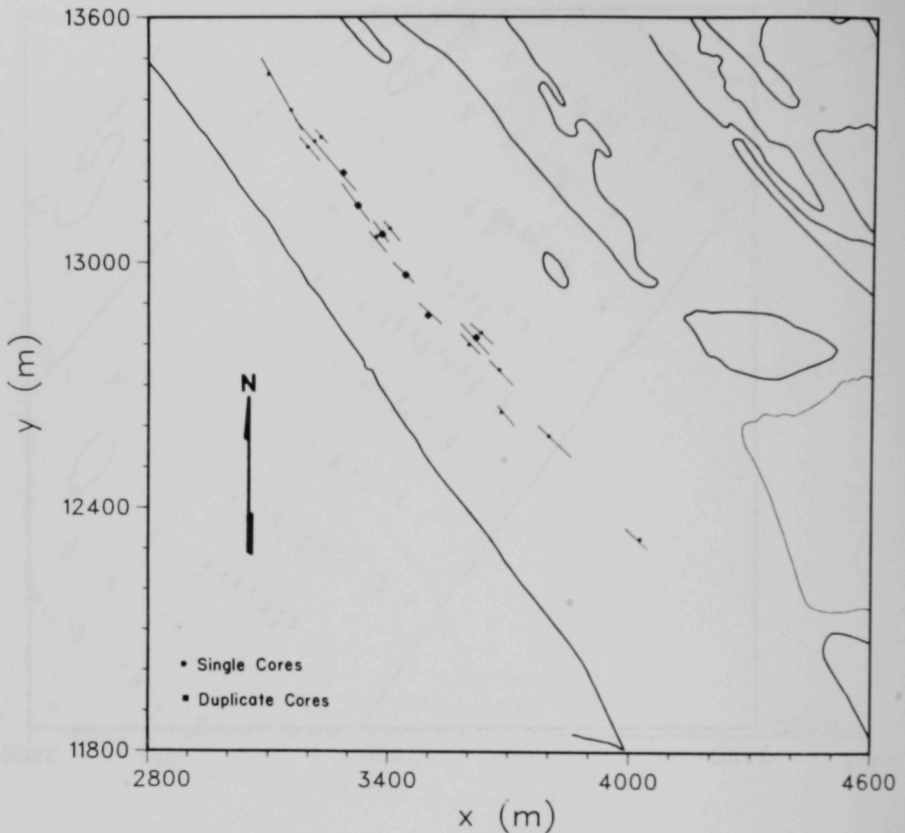
FIGURE 23 Map of Gordon's Ferry Site Showing Coring Locations and Bathymetric Transects

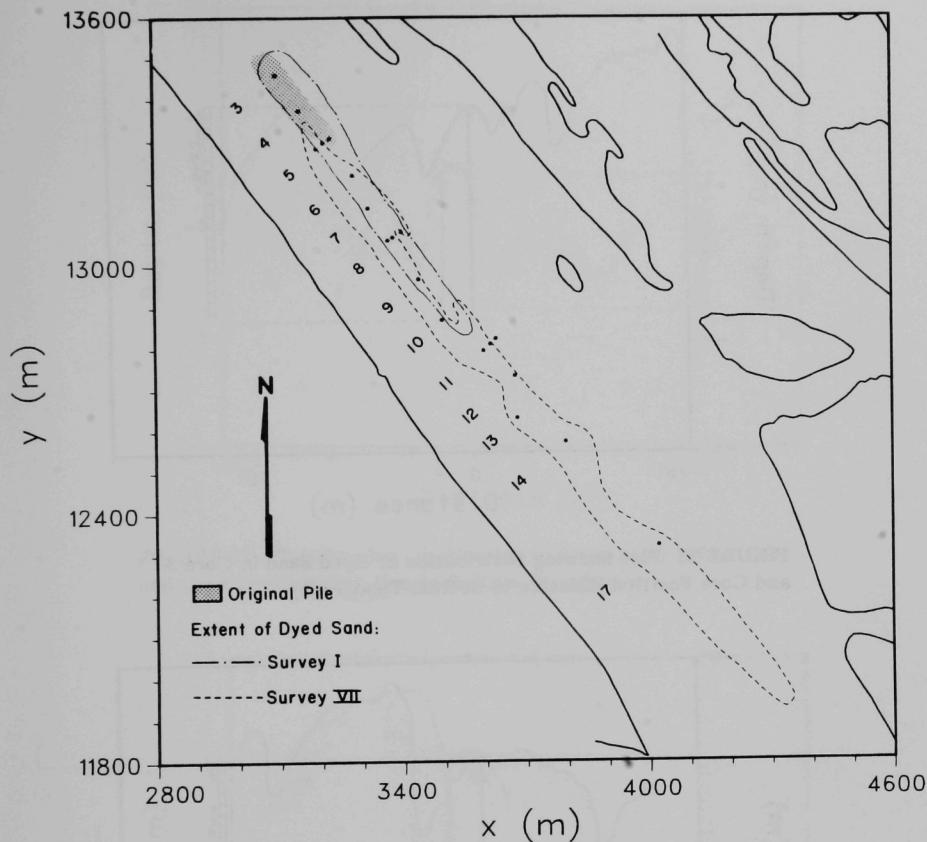
FIGURE 24 Map of Gordon's Ferry Site Showing the Coring Locations, the Original Disposal Pile, and the Three-Dyed-Sand-Grain Contours from Surveys I and VII

As shown in Fig. 24, the primary coring locations lie along the approximate centerline of the area enclosed by the three-dyed-sand-grain contour (i.e., area of highest counts of dyed sand grains). The cores are designated by Arabic numerals that correspond to the designations of the sampling transects for the bottom sampling surveys. The secondary locations to either side of the approximate centerline locations are designated either NE or SW according to whether they are northeast or southwest of the centerline. For example, core 5NE is located about 20 m northeast of core 5 along transect 5. If two cores were collected at the same location, they are designated by an A or B after the core location number. All duplicate cores were collected at the centerline locations.

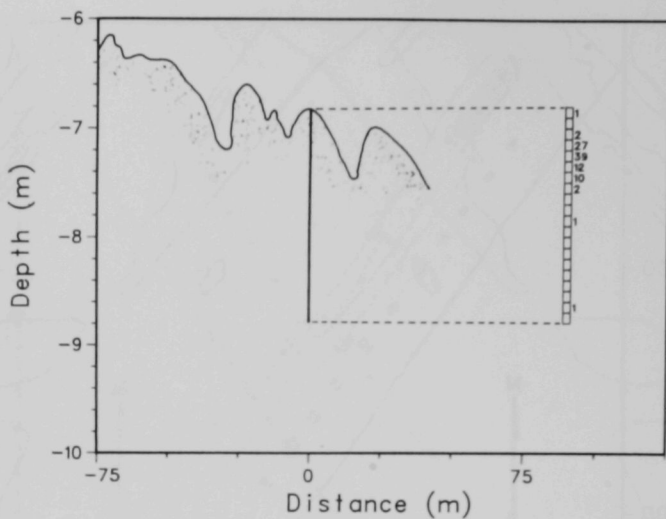
FIGURE 25 Plot Showing Distribution of Dyed Sand in Core 3 and Core Position Relative to Bottom Topography

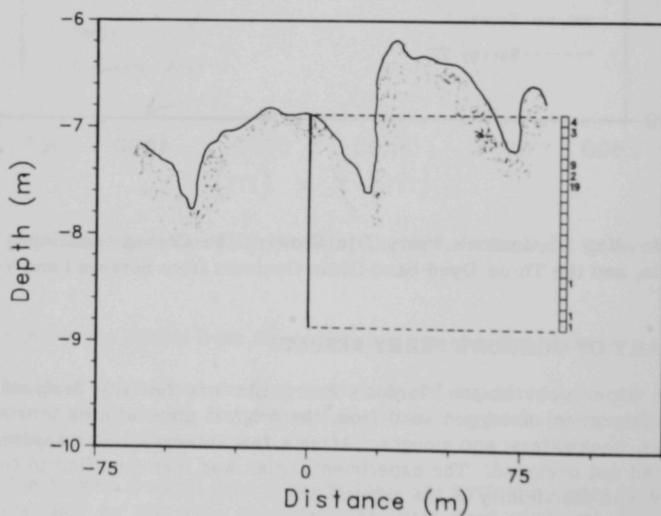
FIGURE 26 Plot Showing Distribution of Dyed Sand in Core 4 and Core Position Relative to Bottom Topography

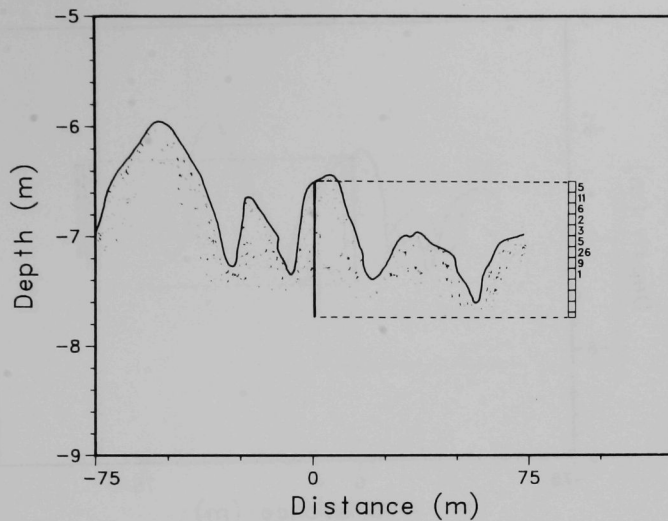
FIGURE 27 Plot Showing Distribution of Dyed Sand in Core 5 and Core Position Relative to Bottom Topography

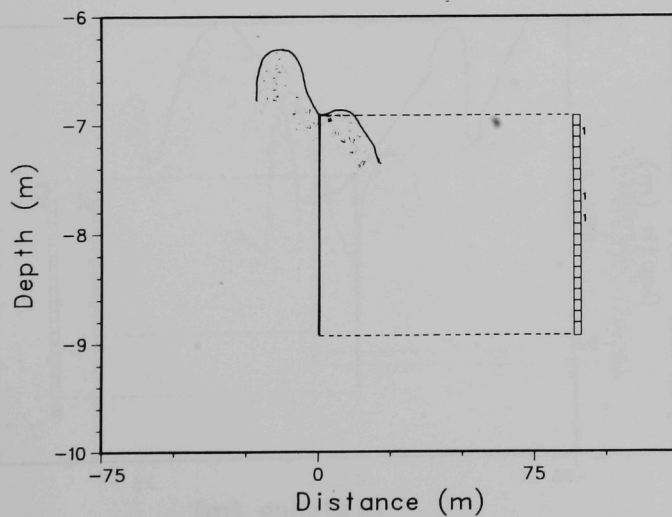
FIGURE 28 Plot Showing Distribution of Dyed Sand in Core 5NE and Core Position Relative to Bottom Topography

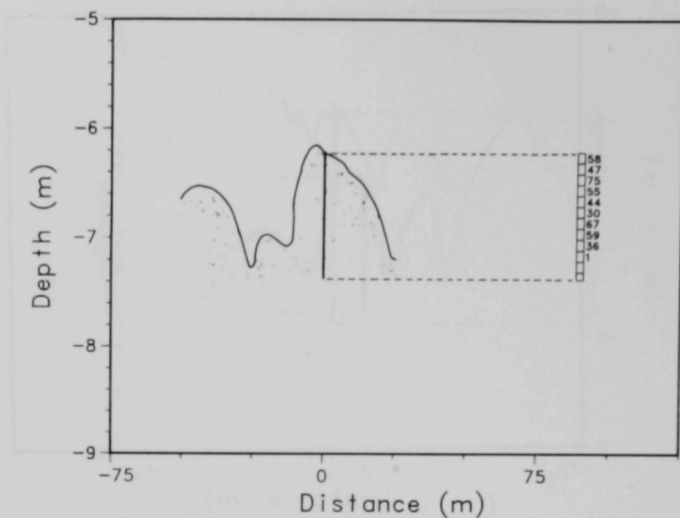
FIGURE 29 Plot Showing Distribution of Dyed Sand in Core SSW and Core Position Relative to Bottom Topography

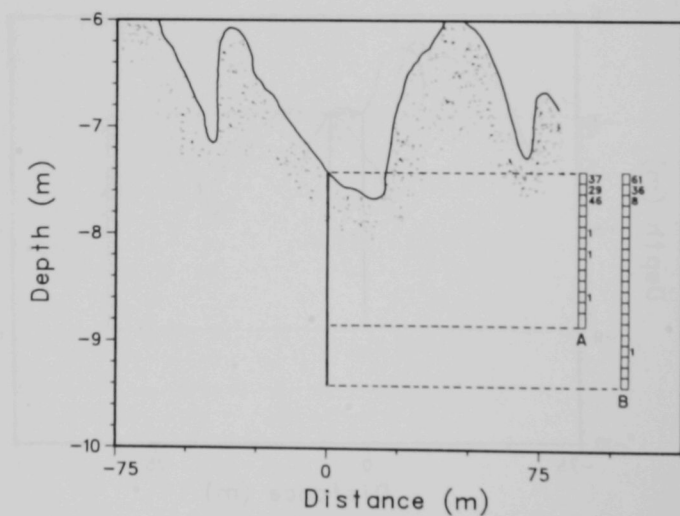
FIGURE 30 Plot Showing Distribution of Dyed Sand in Cores 6A and 6B and Core Position Relative to Bottom Topography

in a core, its vertical extent approximately corresponded to the height of the dune above nearby troughs. Four cores (6A, 6B, 8NE, and 12) collected near a trough contained dyed sand to depths of 30, 30, 40, and 30 cm, respectively. (Core 12 was actually about midway from the trough to the crest, but the dune was small.) The remaining cores were collected at or near dune crests; all contained dyed sand to at least a depth of 70 cm. With the exception of cores collected in troughs, dyed sand was found in all cores taken in locations where dyed sand was found in the surficial bottom sediments.

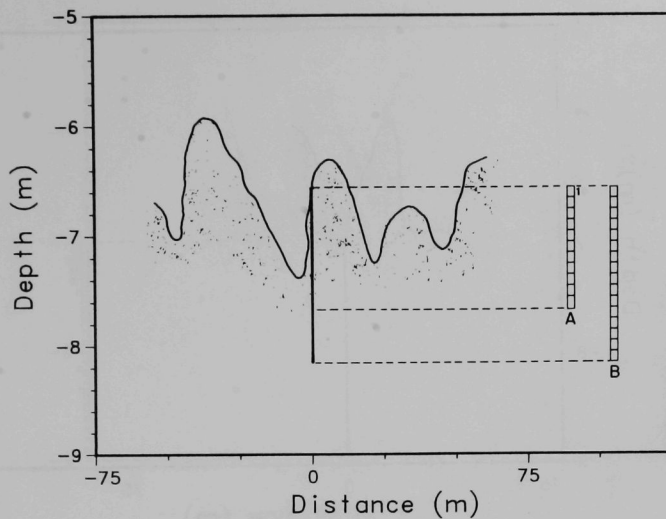
FIGURE 31 Plot Showing Distribution of Dyed Sand in Cores 7A and 7B and Core Position Relative to Bottom Topography

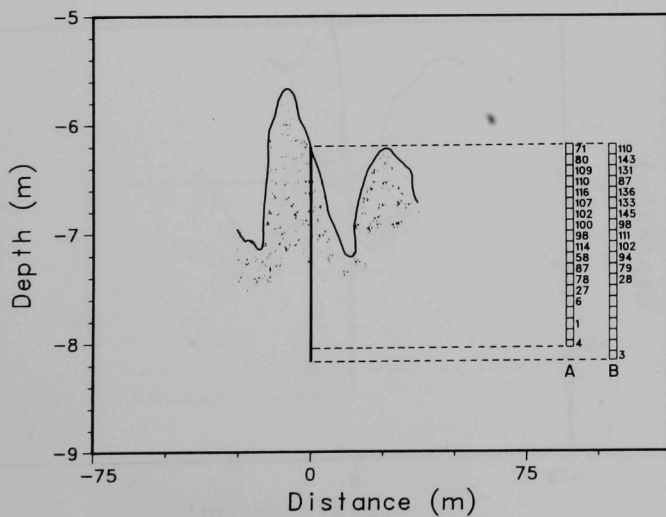
FIGURE 32 Plot Showing Distribution of Dyed Sand in Cores 8A and 8B and Core Position Relative to Bottom Topography

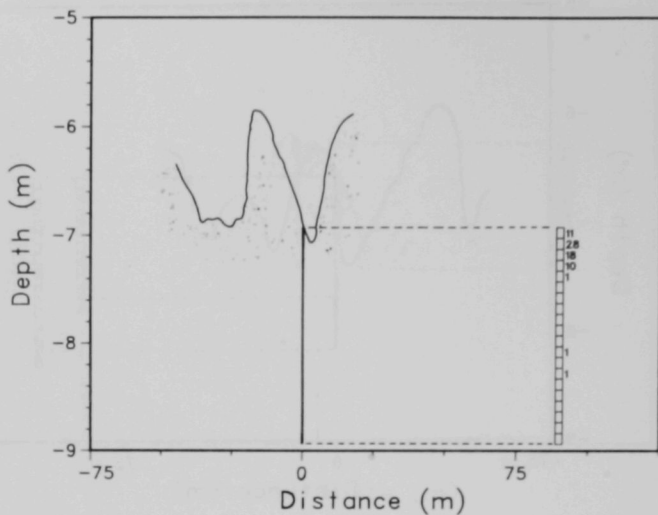
FIGURE 33 Plot Showing Distribution of Dyed Sand in Core 8NE and Core Position Relative to Bottom Topography

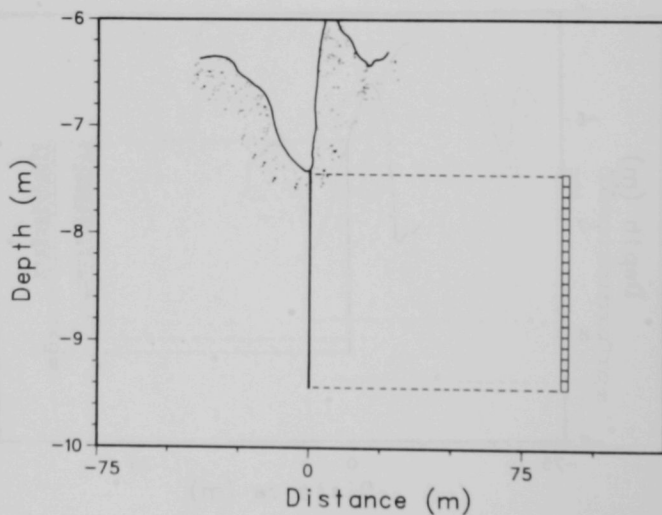
FIGURE 34 Plot Showing Distribution of Dyed Sand in Core 8SW and Core Position Relative to Bottom Topography

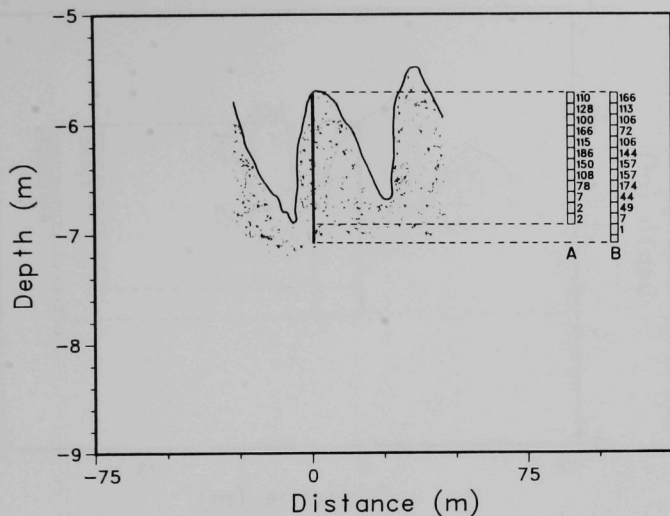
FIGURE 35 Plot Showing Distribution of Dyed Sand in Cores 9A and 9B and Core Position Relative to Bottom Topography

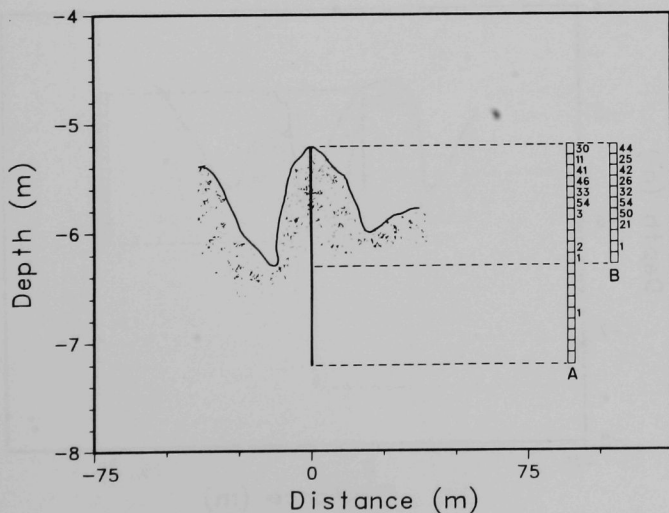
FIGURE 36 Plot Showing Distribution of Dyed Sand in Cores 10A and 10B and Core Position Relative to Bottom Topography

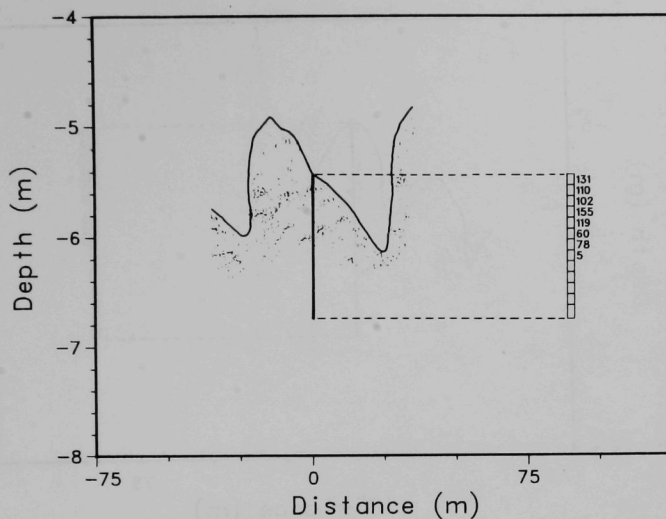
FIGURE 39 Plot Showing Distribution of Dyed Sand in Core 11SW and Core Position Relative to Bottom Topography

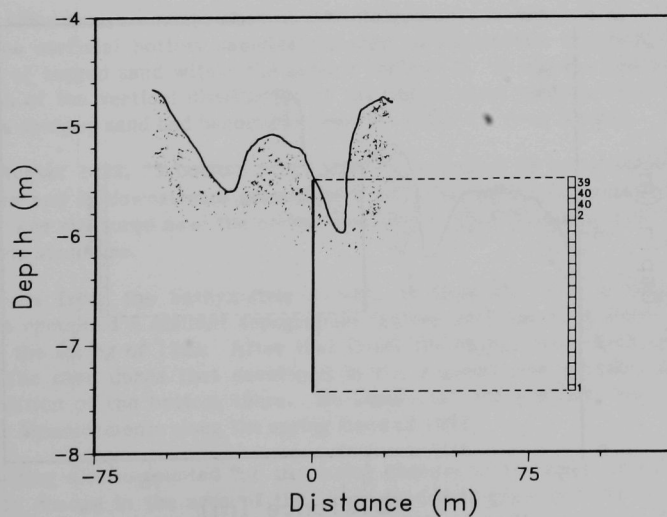
FIGURE 40 Plot Showing Distribution of Dyed Sand in Core 12 and Core Position Relative to Bottom Topography

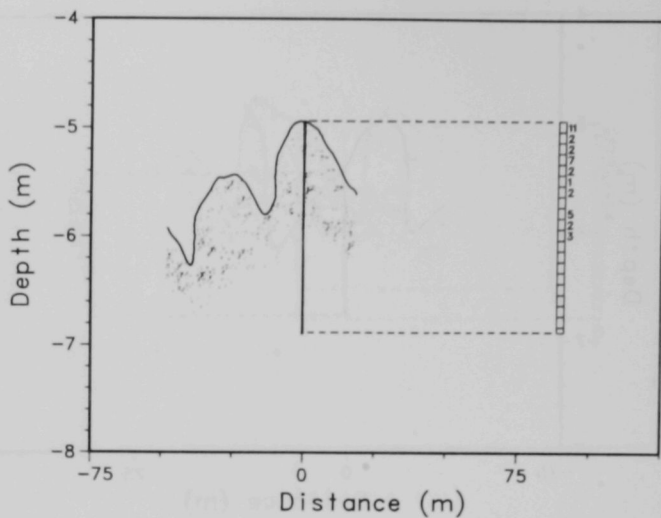
FIGURE 41 Plot Showing Distribution of Dyed Sand in Core 13 and Core Position Relative to Bottom Topography

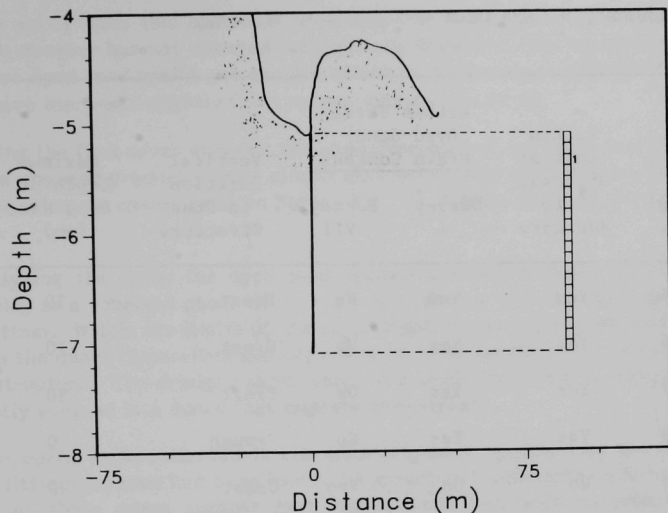
FIGURE 43 Plot Showing Distribution of Dyed Sand in Core 17 and Core Position Relative to Bottom Topography

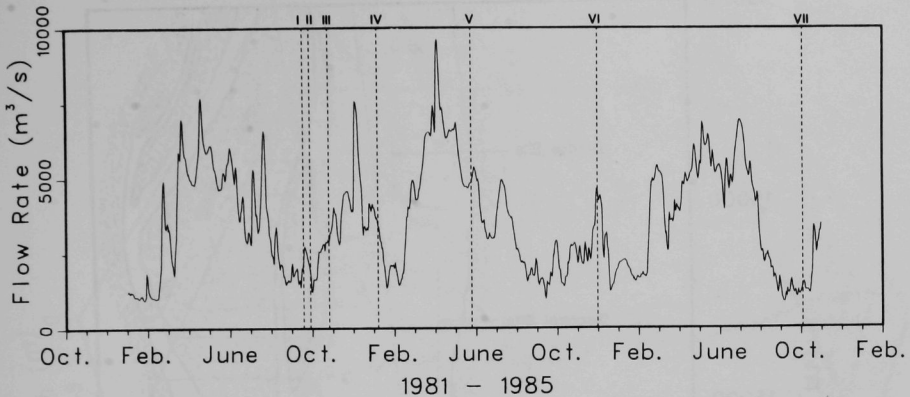
FIGURE 44 Mean Daily River Discharge for the Whitney Island Site as Recorded at Lock and Dam 22, with the Dates of the Surveys Indicated

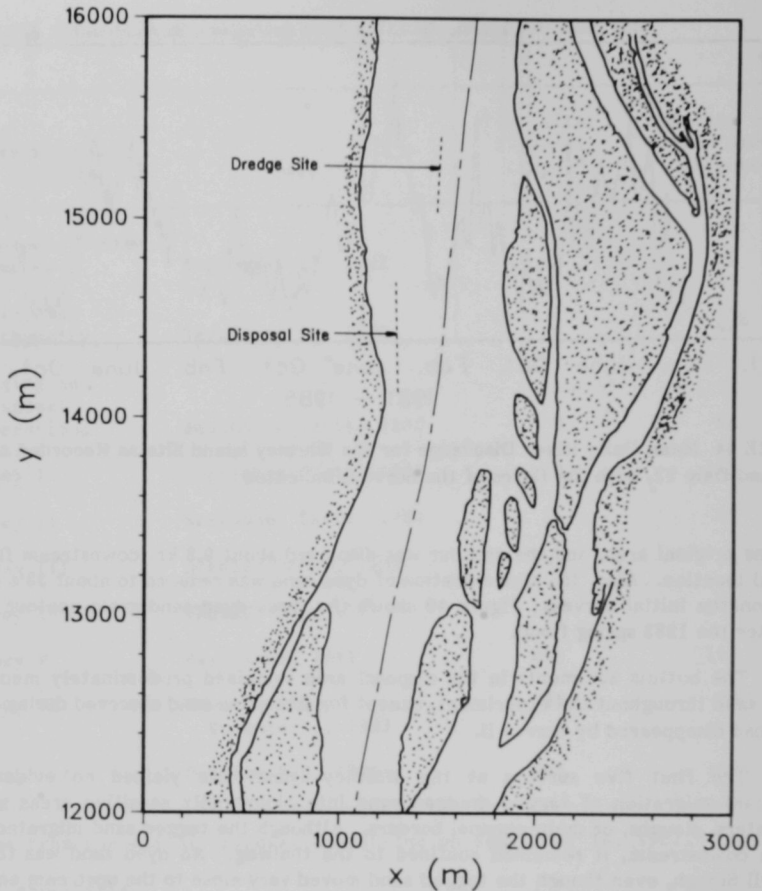
FIGURE 45 Map of Whitney Island Site Showing Dredging and Disposal Areas

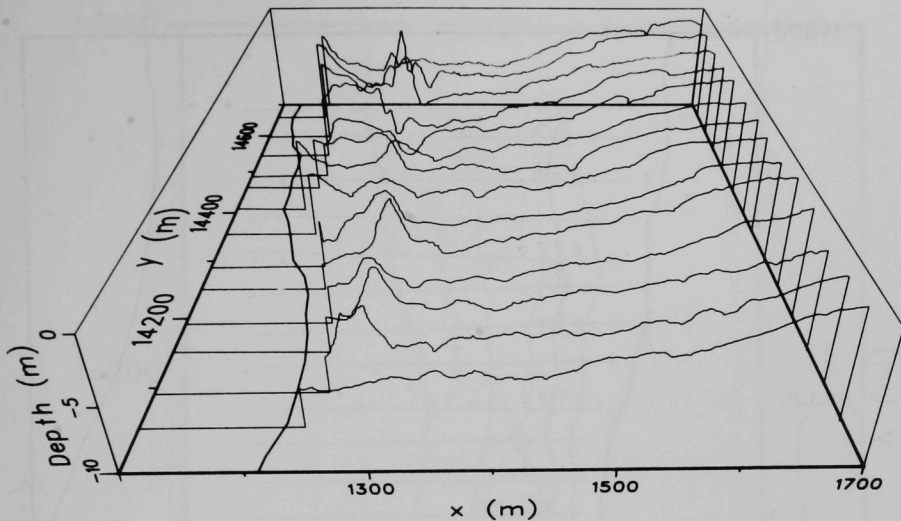
FIGURE 46 Perspective Plot of Transverse Bathymetric Transects for Survey I at the Whitney Island Disposal Site

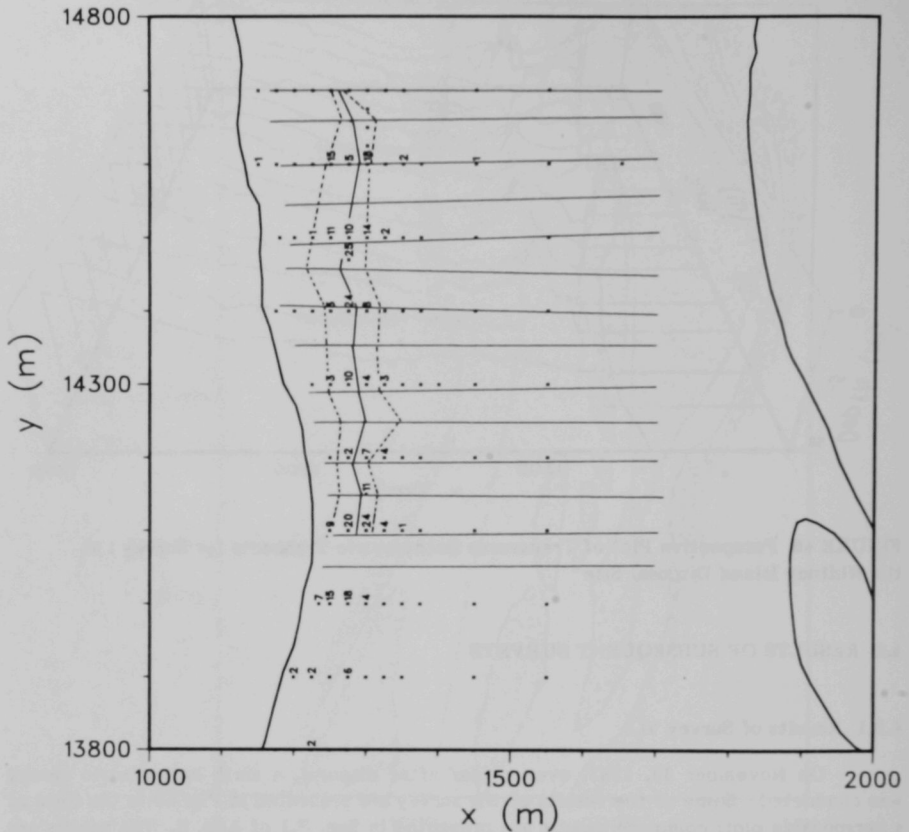
FIGURE 47 Location of Bathymetric Transects and Bottom Sampling Stations for Survey I at the Whitney Island Disposal Site (extent of the pile and number of dyed sand grains observed are also noted)
